Our ref: EJM/CE/17016-03

28th April 2016

RE: THE FUTURIST, LIME STREET, LIVERPOOL

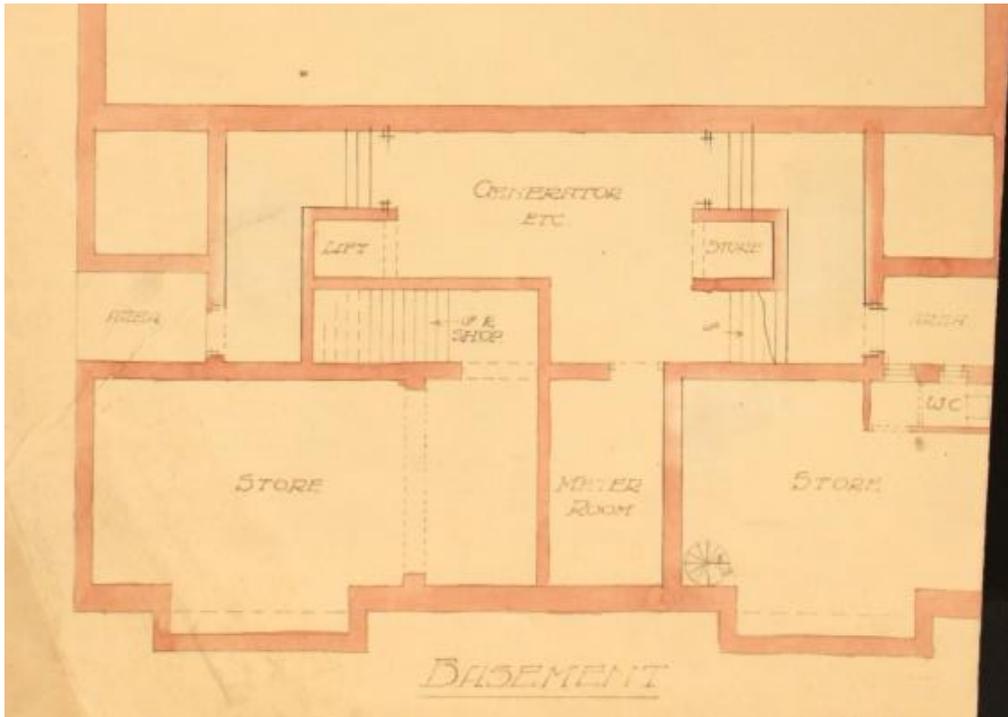
Basement Plan (front only)

Firstly in the basement there are two cross walls, one positioned where I expected (13 ½" thick I suspect) and one additional one, albeit appearing slightly narrower (9" thick I suspect). There appears to be a steel beam under the second position I was anticipating seeing a wall.

This is positive as it shows that there are some walls which have a buttressing effect on the front wall, and thus will assist with any temporary works scheme externally, by helping resist any surcharge developed. Of course this depends on them being in reasonable condition.

Secondly the basement plan shows the brickwork steps out towards Lime Street, to each shop unit (see attached part basement plan). Again subject to inspection of condition this may mean that any temporary steel frame structure may be able to reside over this and thus the walls would be in compression rather than surcharging the basement wall with lateral pressure. It also means that services in the pavement should run outside this line. This would be subject to checking the alignment of the walls carefully, their condition and also thickness and thus their ability to take load without buckling. Of course the plan of the front wall at basement level, with the steps in its length will also provide some stiffening to resist this action, as opposed to a continuous wall along the length of the building.

So subject to verification of the accuracy of the plans, that no changes or subsequent alterations have occurred at basement level, and the condition, I believe this reinforces the conclusion in my previous letter that a temporary works scheme to provide lateral support the front elevation should be perfectly possible.

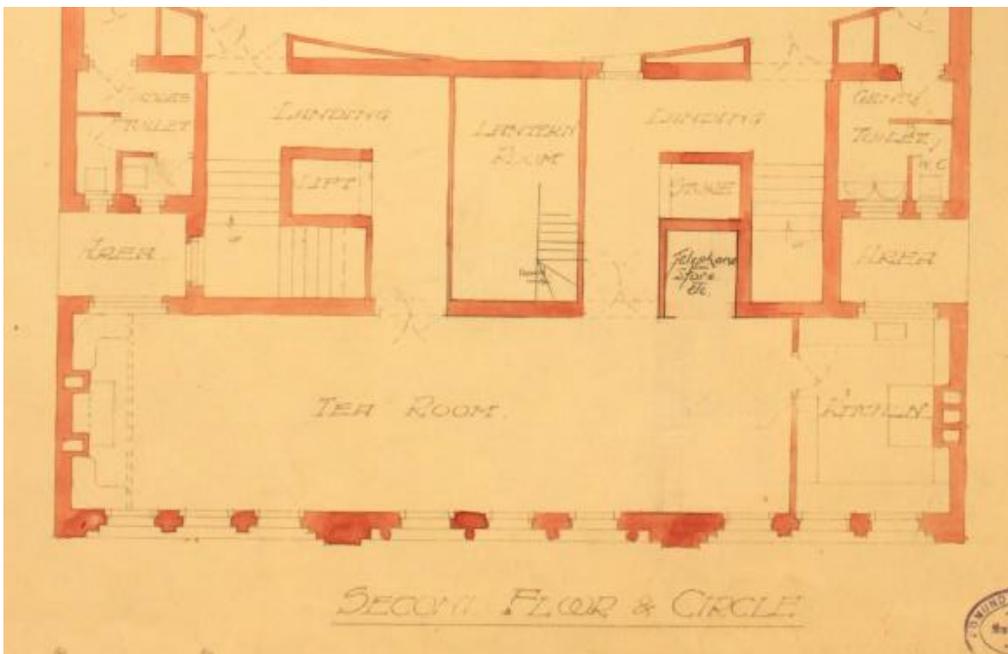
Second Floor (front only)

The second item which comes out of the plans is that the second floor plan shows that, in fact, this was largely an open space (a tea room) then with a kitchen at one end. However now there are more cross walls. This leads me to the conclusion that the out of plumb of the front elevation occurred prior to the insertion of these cross walls, as otherwise there would have been movement cracks, and thus I conclude that no movement has occurred since the walls were added. This is with the exception of the wall which is strapped.
